Engineering Thesis

Tjuntjuntjara Groundwater Desalination

Simon Digby

Submitted to the Murdoch University School of Engineering and Energy to partially fulfil the requirements of a Bachelor of Engineering.

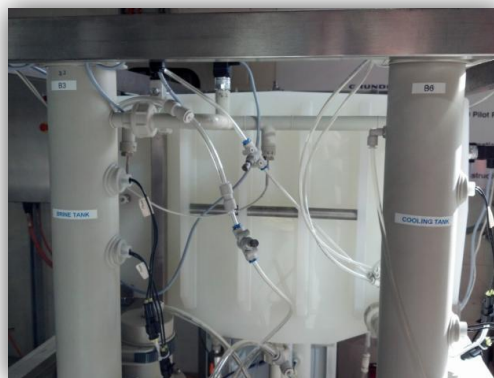
There are two different types of piping used to transport the process materials around the plant. The first is a standard PVC that is used for the flow of cooling and heating water, distillate and brine around the plant. The second is applied to supply the system vacuum for the module and storage vessels. The two different types can be seen in Figure 5, below.

Figure 5 - PVC process piping and polyurethane vacuum tubing

The main concern with the PVC piping is its rigidity compared to strength. In transportation the tendencies for things to be vibrated would likely lead to the piping being fractured. Therefore, it would need to be disassembled before transportation and re-assembled onsite. Since the vacuum lines are flexible polyurethane tubing the only concern would be the push fit connections. However, after working with these connections they have been found to be strong and maintain a good seal.

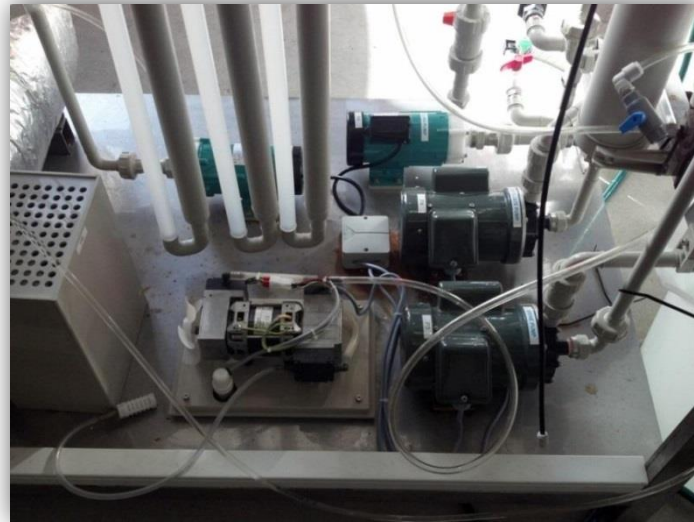
The choice of pumps for the VMEMD plant is quite crucial because the corrosive process fluid and low pressures are not ideal conditions for a pump to operate in. Furthermore, the distillate and brine pumps are started and stopped very frequently. The pumps selected for the distillate and brine outputs are Iwaki magnetic drive turbine pumps and the cooling loop and heating loop top-up pumps are Iwaki magnetic drive pumps. Magnetically driven pumps are advantageous in this situation because the pumping chamber is separated from the motor, there are no drive seals and frictional losses are minimised.

The saline water is not exposed to any metallic components in these pumps and therefore no corrosion can occur. With minimal friction the magnetic drive pumps are easier to start and more reliable. A Grundfos pump, of the canned rotor type, was chosen to circulate the heating loop. Still magnetically driven, the canned rotor pump offers the same advantages as the Iwaki pumps. Finally, a KNF diaphragm vacuum pump is used to lower the system pressure. In Figure 6, below, the Iwaki pumps and KNF vacuum pump can be viewed.

Figure 6 - 4 green Iwaki pumps and KNF vacuum pump (with cover removed)

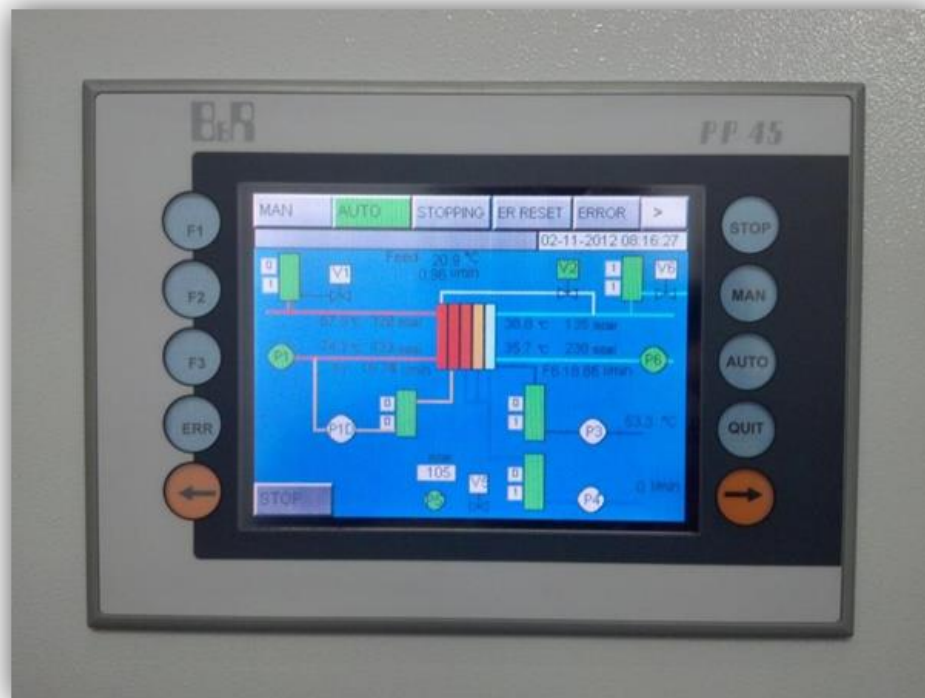
Automation studio allows the design of visualisations, otherwise known as a HMI or operator screen, for the B&R Power Panels. The HMI is used to operate the plant and monitor plant parameters. Figure 8 shows the HMI design for the plant with vessels, valves, pumps, flow lines and the VMEMD module displayed on the main screen. There are screens for changing PLC variables, monitoring plant parameters and others for configuring the PLC. The vast amount of configurability demonstrates that the HMI was designed for testing purposes. With the amount of information displayed by the HMI only a person very familiar with the plant would be able to understand configuration displays.

Figure 8 - VMEMD plant HMI

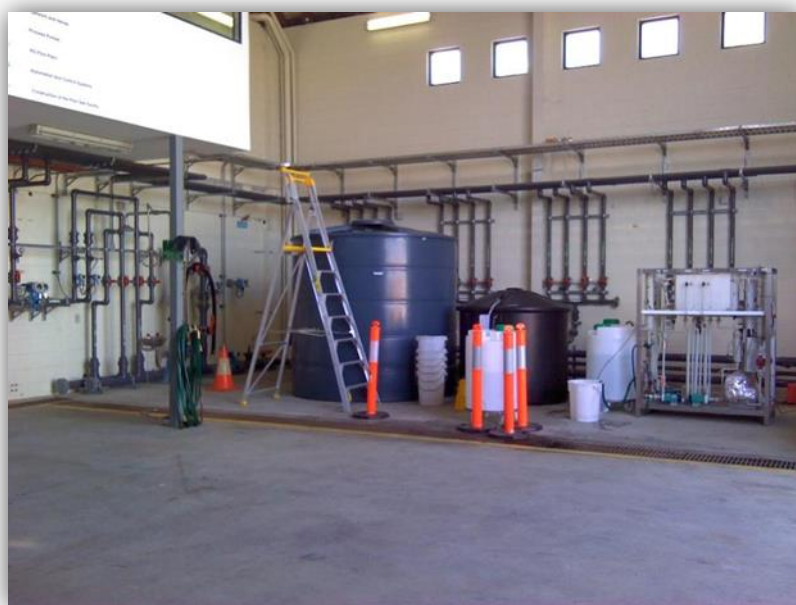
A much larger tank was selected for the H/E fluid in order to dissipate the heat better. Three 200 L tanks were positioned for the distillate and brine output and the heating and cooling loop top-up. The setup of the trial can be viewed in Figure 17 in which the H/E tank (left), feed tank (middle), 3 200L tanks (right) and the plant can be seen.

Figure 17 - Continuous trial setup at the NCED
